Company GIBELA	Name of the request Ntsebeng Mosia	Function: Production	Date: 03/08/2023	Visa	Request N° PRASA-DERSU-1126
			Plant Country DNN	Gibela South Africa	
Project	PRASA PROJECT		Customer	PRASA	
Product name Reference	Underframe DT00000223278 – TC2		Drawing number and Revision	AA00001130996 – Panel AA0001346965 (TC-Car) - Underframe	
Temporary <input checked="" type="checkbox"/>	Quantity: For the affected car : 180 TC2	Serial Numbers / Batch: 180 TC2		Permanent <input type="checkbox"/>	
Requirement: Approval to use aesthetically non-conforming underframe centre panel			Anteriority: Impact on: Environment..... <input type="checkbox"/> Safety (people)..... <input type="checkbox"/> Contract clauses..... <input type="checkbox"/> Economic Development.. <input type="checkbox"/> Product Safety..... <input type="checkbox"/> Reliability..... <input type="checkbox"/> Performances..... <input type="checkbox"/> Delivery..... <input type="checkbox"/> Cost..... <input type="checkbox"/> Documentation..... <input type="checkbox"/> Resources..... <input type="checkbox"/> Others..... <input checked="" type="checkbox"/>

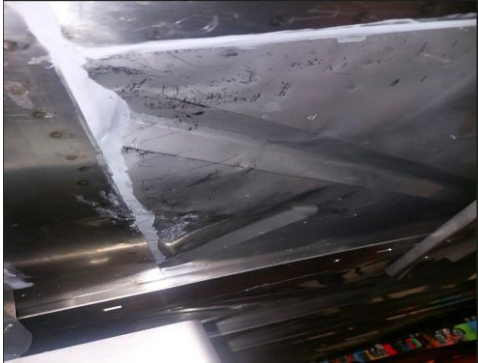
Non-conformity description: Uneven surface on the underframe centre panel					
Cause of the non-conformity / reasons for request: A. Unevenness caused during assembling of the Side sill to the underframe. Side sill clamped whilst panel was not correctly aligned thus caused the panel to be compressed and uneven. B. The center panel cannot be reworked or replaced due the spot gun access and the repair and removal would further cause more damages C. Poor aesthetic on the underframe panel					
Attached documents: Uneven underframe centre panel (Bottom view) Uneven underframe centre panel (top view)

Containment action: 1. Reapply sealant at the bottom panel 2. Use as it			Use or assignment limitations of the non-conforming product: 180 TC2
